NTIAC 74-1

PROCEEDINGS OF THE 1973 SYMPOSIUM ON NONDESTRUCTIVE TESTING OF TIRES

Sponsored by
ARMY MATERIALS AND MECHANICS RESEARCH CENTER
Watertown, Massachusetts 02172

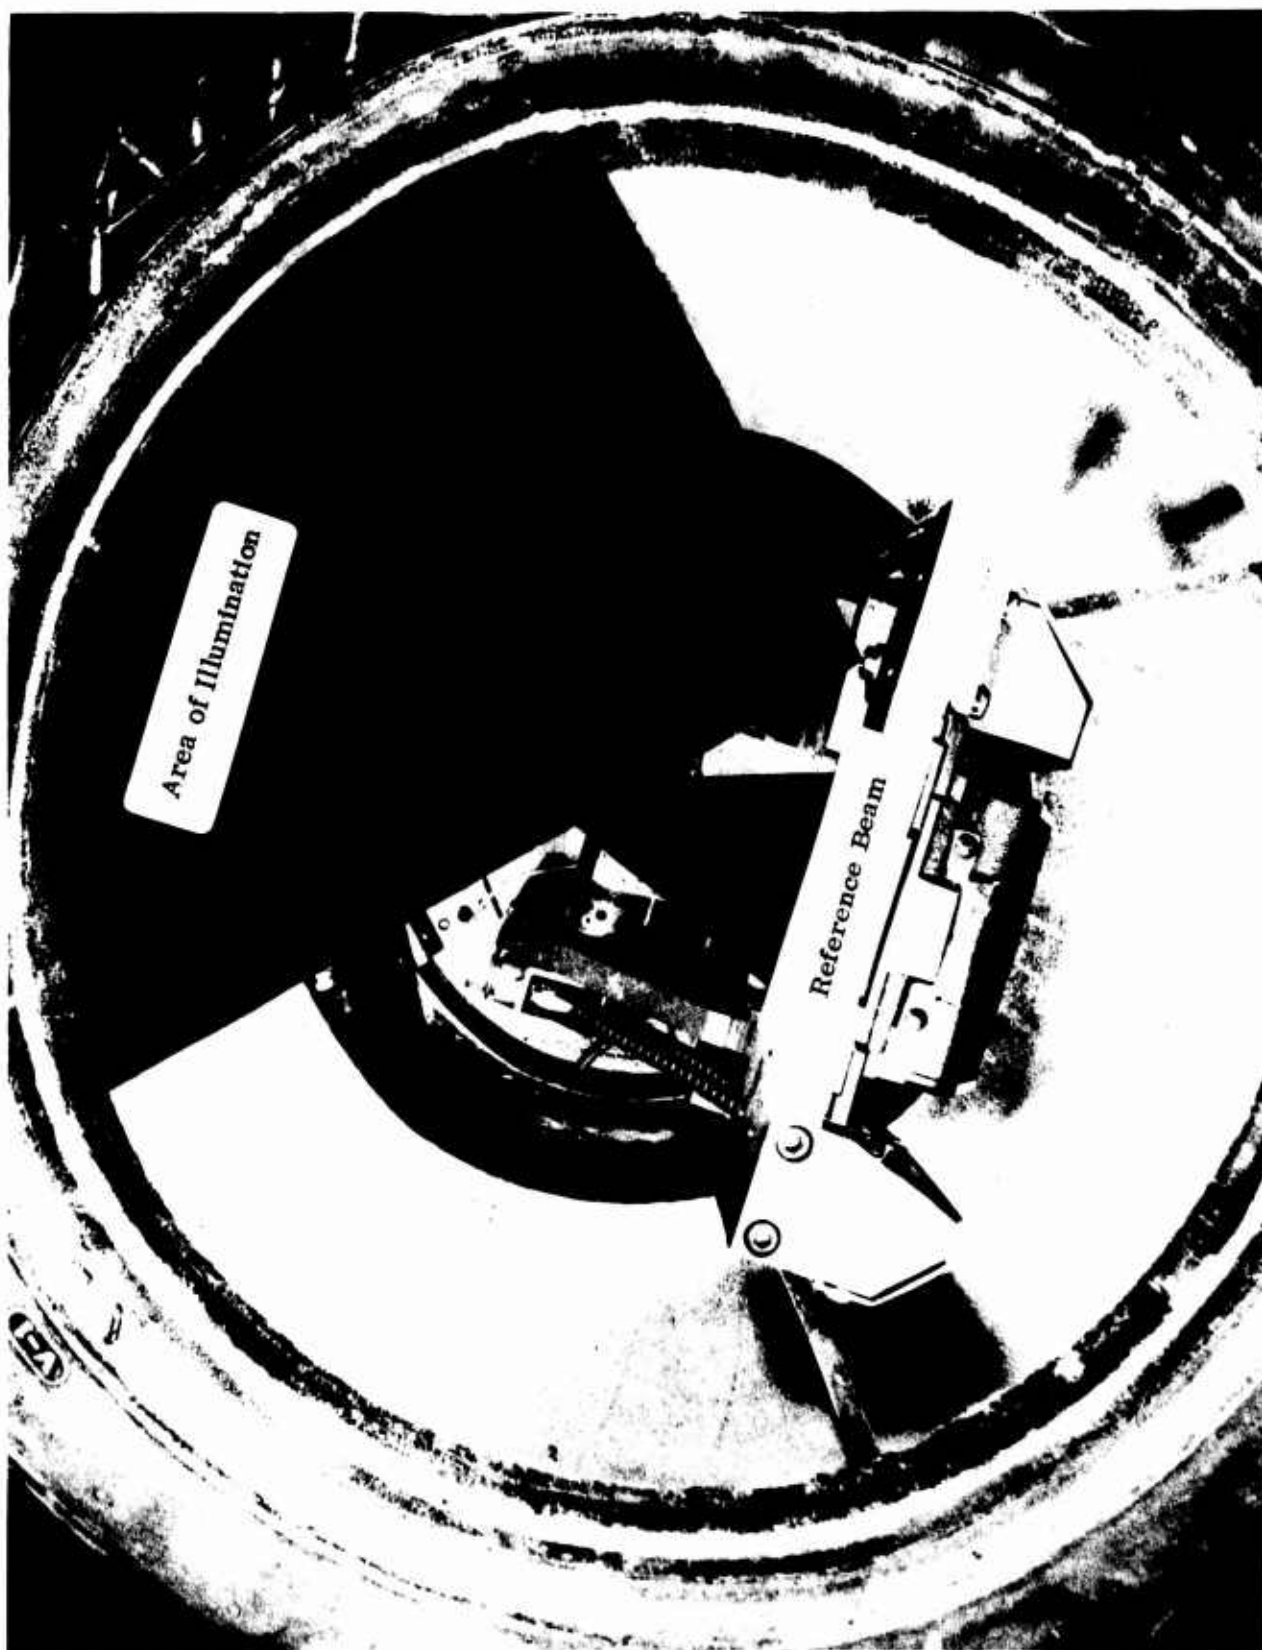
FIGURE 2d
OVERALL VIEW OF OPTICS PACKAGE SHOWING SPREAD TIRE

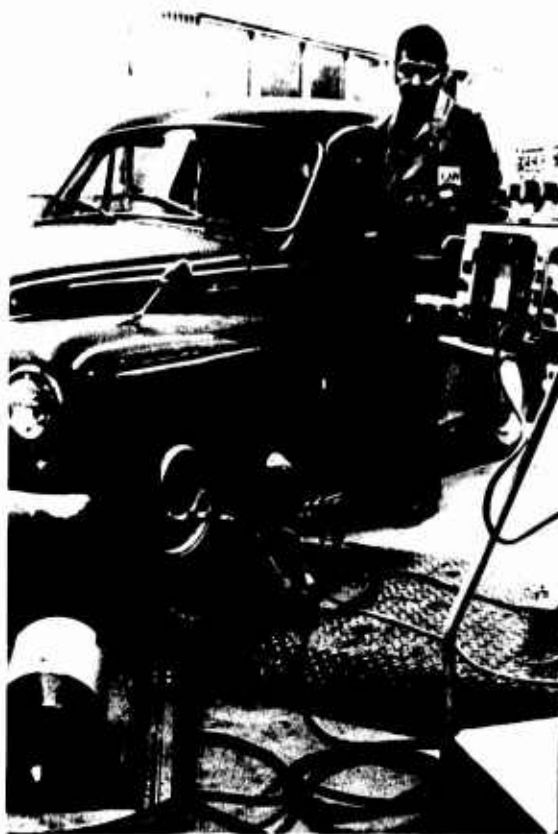
FIGURE 4
ACTUAL SETUP AT A SWEDISH AUTOMOBILE INSPECTION STATION, WHERE THE THERMAL IMAGES OF RETREADED TIRES WERE INVESTIGATED

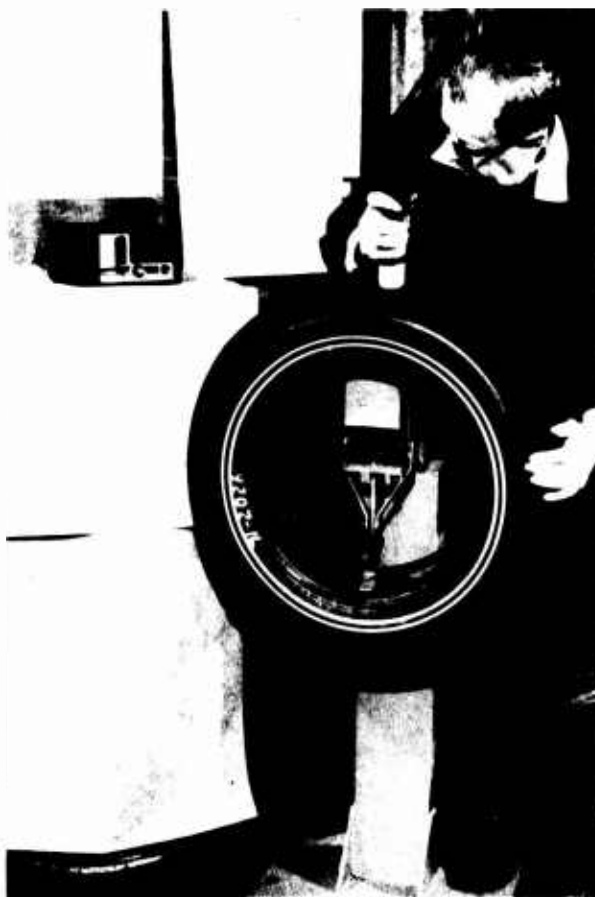
FIGURE 21

We have equipped our passenger tire retread plants with variable inductance transducer systems (Figure 21) to measure the thickness of the tire carcass after the buffing operation. This system is limited to comparatively small thicknesses but has enabled us to retread fiberglass belted tires without buffing into the belt. The operation of the system is simple enough that the retread laborer can use it with little instruction. This system is used as a process control and not to inspect outgoing finished products. However, the buff limits have been established by our Retread and Repair Development Department after extensive testing against the original DOT compliance standards for retreaded tires.

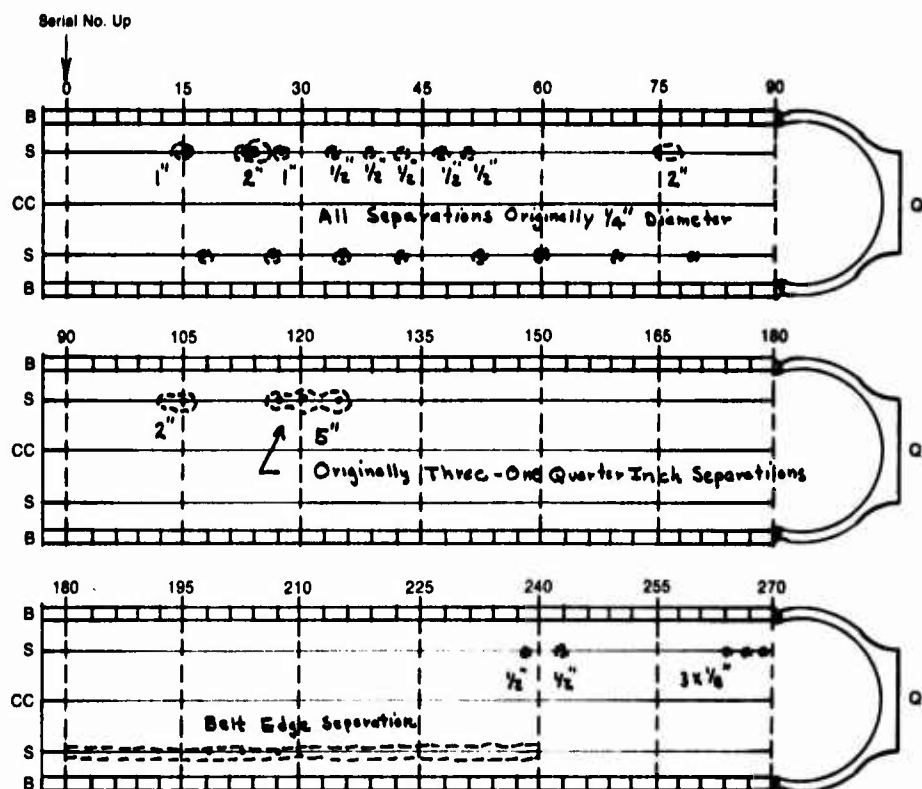
original $1/4$ inch separations which grew to an average of ($1/2 \pm 1/8$) inch. This region is just beginning to get weak. Note that three $1/4$ inch ones at $120^\circ \pm 3^\circ$, which were more closely clustered, brought about a five inch separation on the upper stabilizer ply edge and the three very small ones at 198° , 203° and 208° brought about a 60° mild opening of the belt edge between 180° and 240° . Despite remaining tread depth, this tire could fail prior to total run out. The tire should obviously not be recapped.

FIGURE 23
CHART OF SEPARATIONS IN TIRE EXAMPLE IX

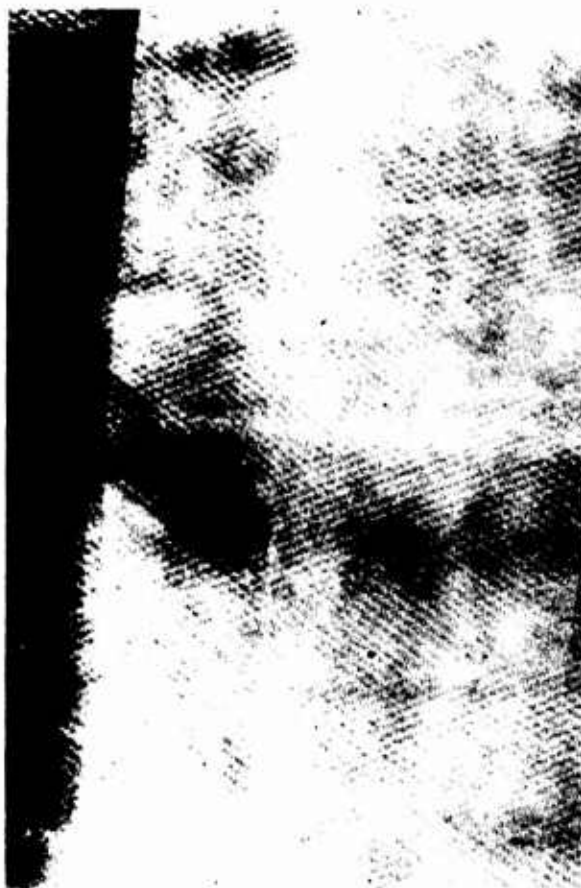
FIGURE 1
OFF-SET (DOG-EAR) IN PLY TURN UP WIDE PLY SPLICE

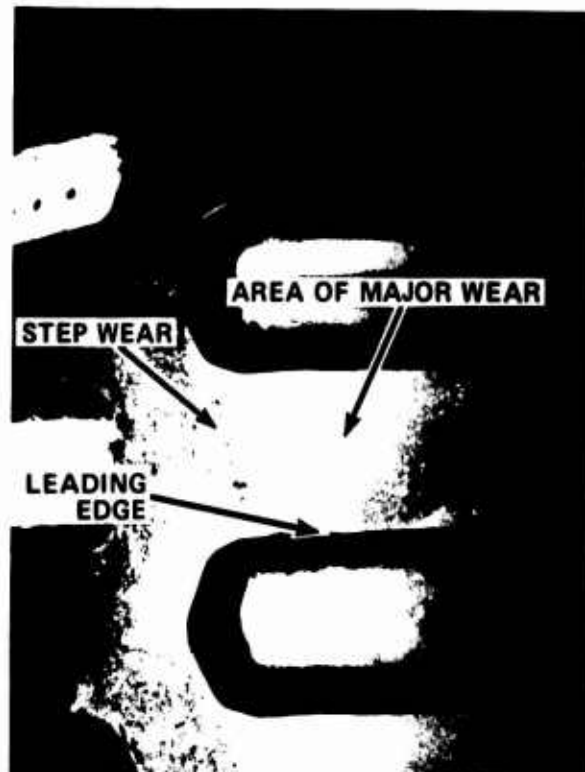
TORQUE	-100 ft/lb
SLIP ANGLE	0°
LOAD	800 lb
INFL PRESSURE	20 psi
SPEED	60 mph
DISTANCE TRAVELED	240 miles
TIRE NO.	29

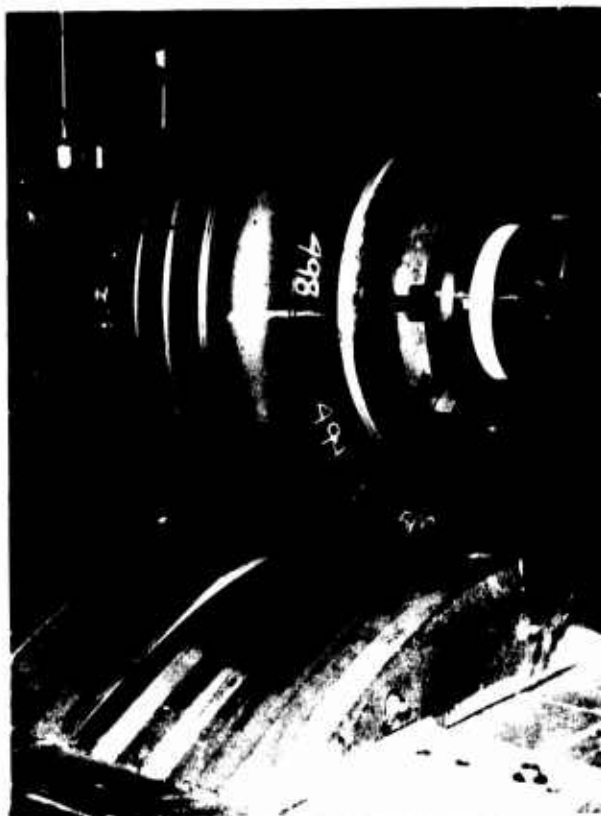
FIGURE 16 MEASURING STRESS
NORMAL TO TIRE TREAD AND CARCASS

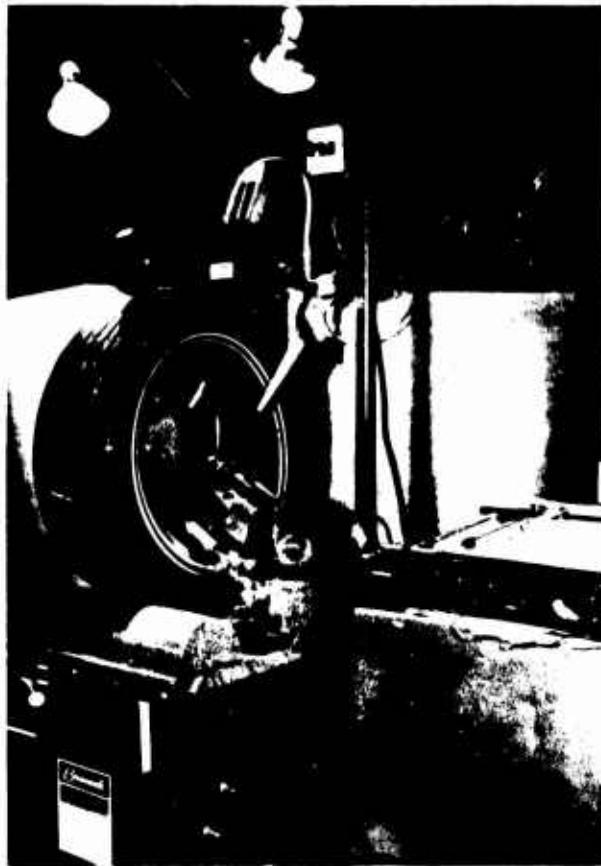
FIGURE 1
AN AUTOMATIC TIRE INSPECTION MACHINE WITH
A BEAD-INSPECTION ADAPTER (BIA) ATTACHED
TO THE SPREADER ARM
